Report on the investigation of  
the collision between the ro-ro passenger ferry

***Red Falcon***

***Greylag***

on 21 October 2018

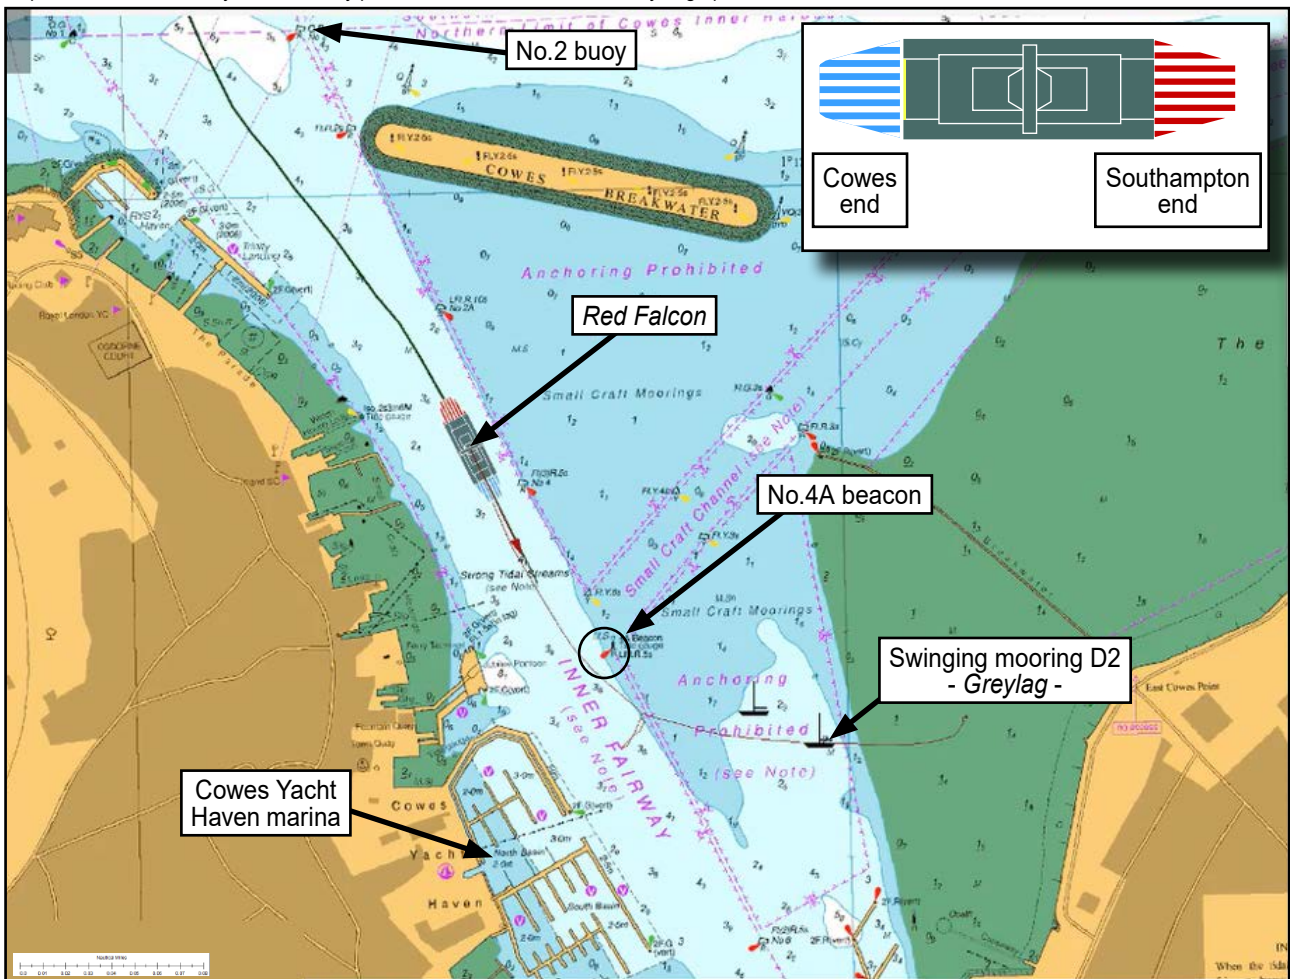
Figure 4: Red Falcon passage track into Cowes Harbour

In anticipation of a small east to west cross-stream near to the inner fairway's No.4 buoy, the master ordered a course to steer that took the ferry to the east of the channel centre line, close to the port hand channel buoys. At 0807, as *Red Falcon* approached No.4 buoy, the deck lookout called the bridge on his hand-held Ultra High Frequency (UHF) radio and reported that the vessel was close to the buoy (**Figure 4**), and that it needed to be brought to starboard.

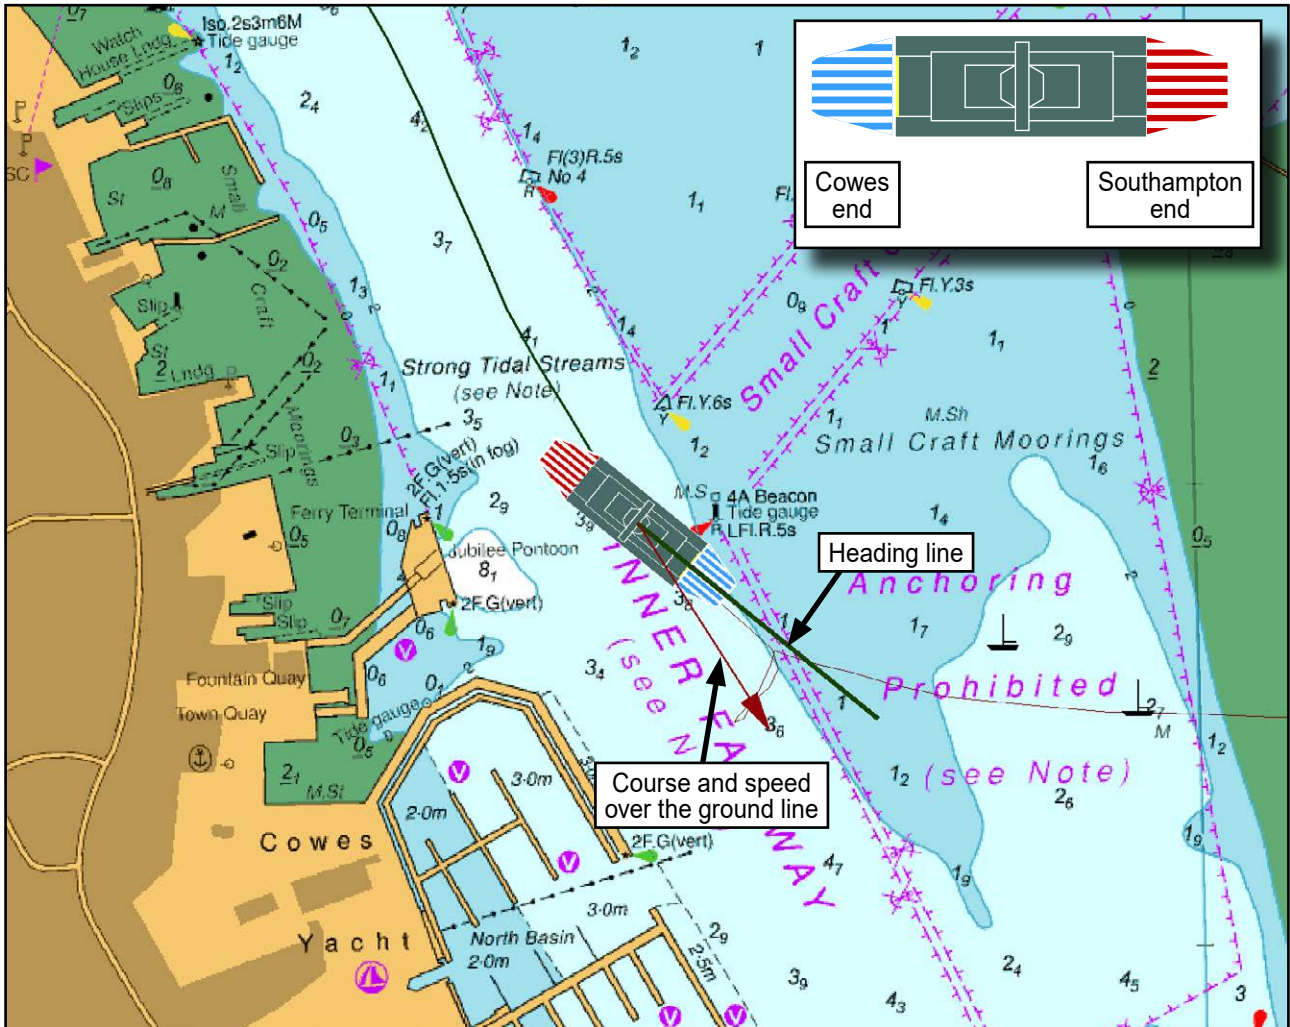
Figure 6: Red Falcon starting to swing out of the channel

The master managed to arrest the vessel's swing briefly but, at 0808:30, *Red Falcon* started to swing to port once again as it passed close to No.4a beacon (**Figure 6**). The master attempted to stop the vessel's swing, but as the Cowes end of the ferry left the inner fairway to the east, just missing the No.4a beacon, the Southampton end spun round quickly. At this point the visibility closed in even further and the bridge team were no longer able to visually identify the shoreline or navigation marks. The C/O continued to provide the master with his own observations and updates from the deck lookout.

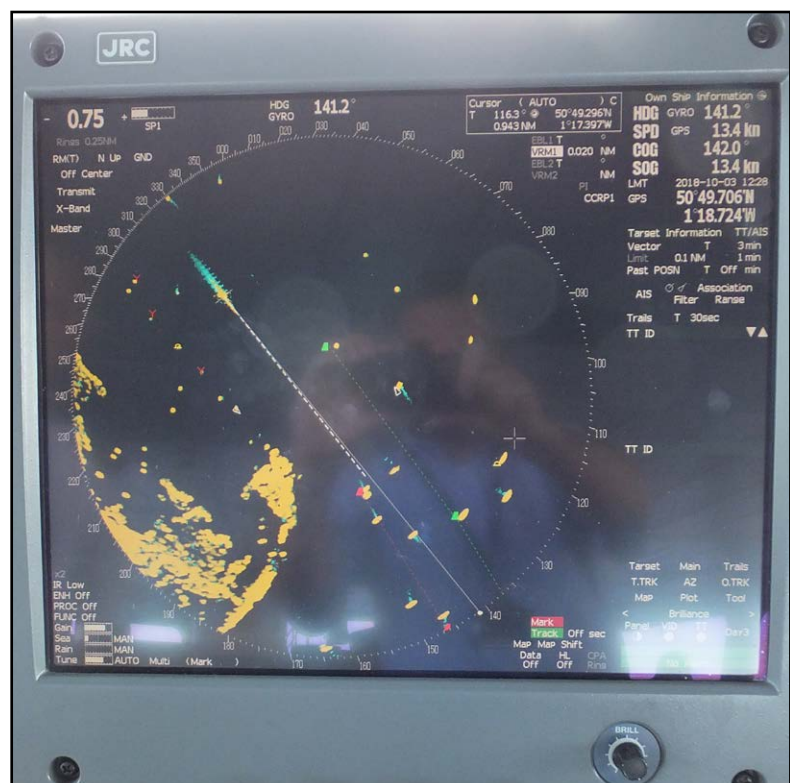
**Figure 15:** Radar picture offset (approaching Calshot Spit, not in Cowes Harbour)

On the passage to Cowes, the aft radar display operated by the C/O was offset to the north-west. Just before *Red Falcon* entered Cowes, the C/O reduced the range scale in use from 1.5 to 0.75nm, but the radar picture remained offset to the north-west, and was not reset until after the accident (**Figure 15**).
