Report on the investigation of  
the collision between the ro-ro passenger ferry

***Red Falcon***

***Greylag***

on 21 October 2018

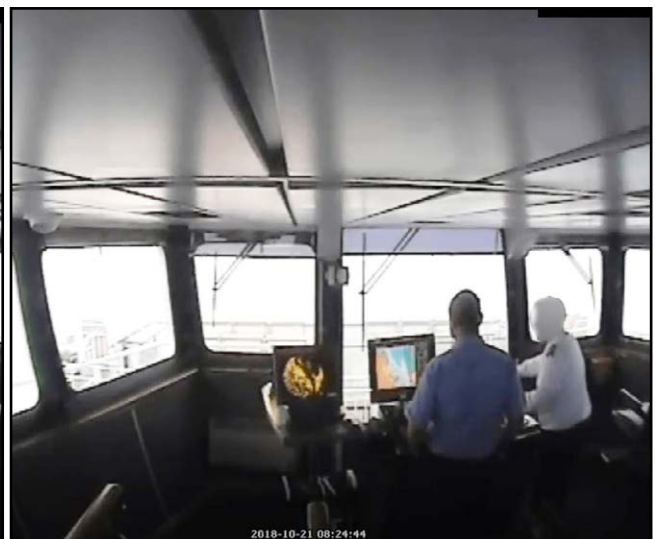
Figure 5b: Master and helmsman position after master took over control

when the master took over from the helmsman he could no longer see the radar display (**Figure 5b**). It was therefore much more likely that the swivel mounted ECS display closer to the VSP controls would be used for navigation.

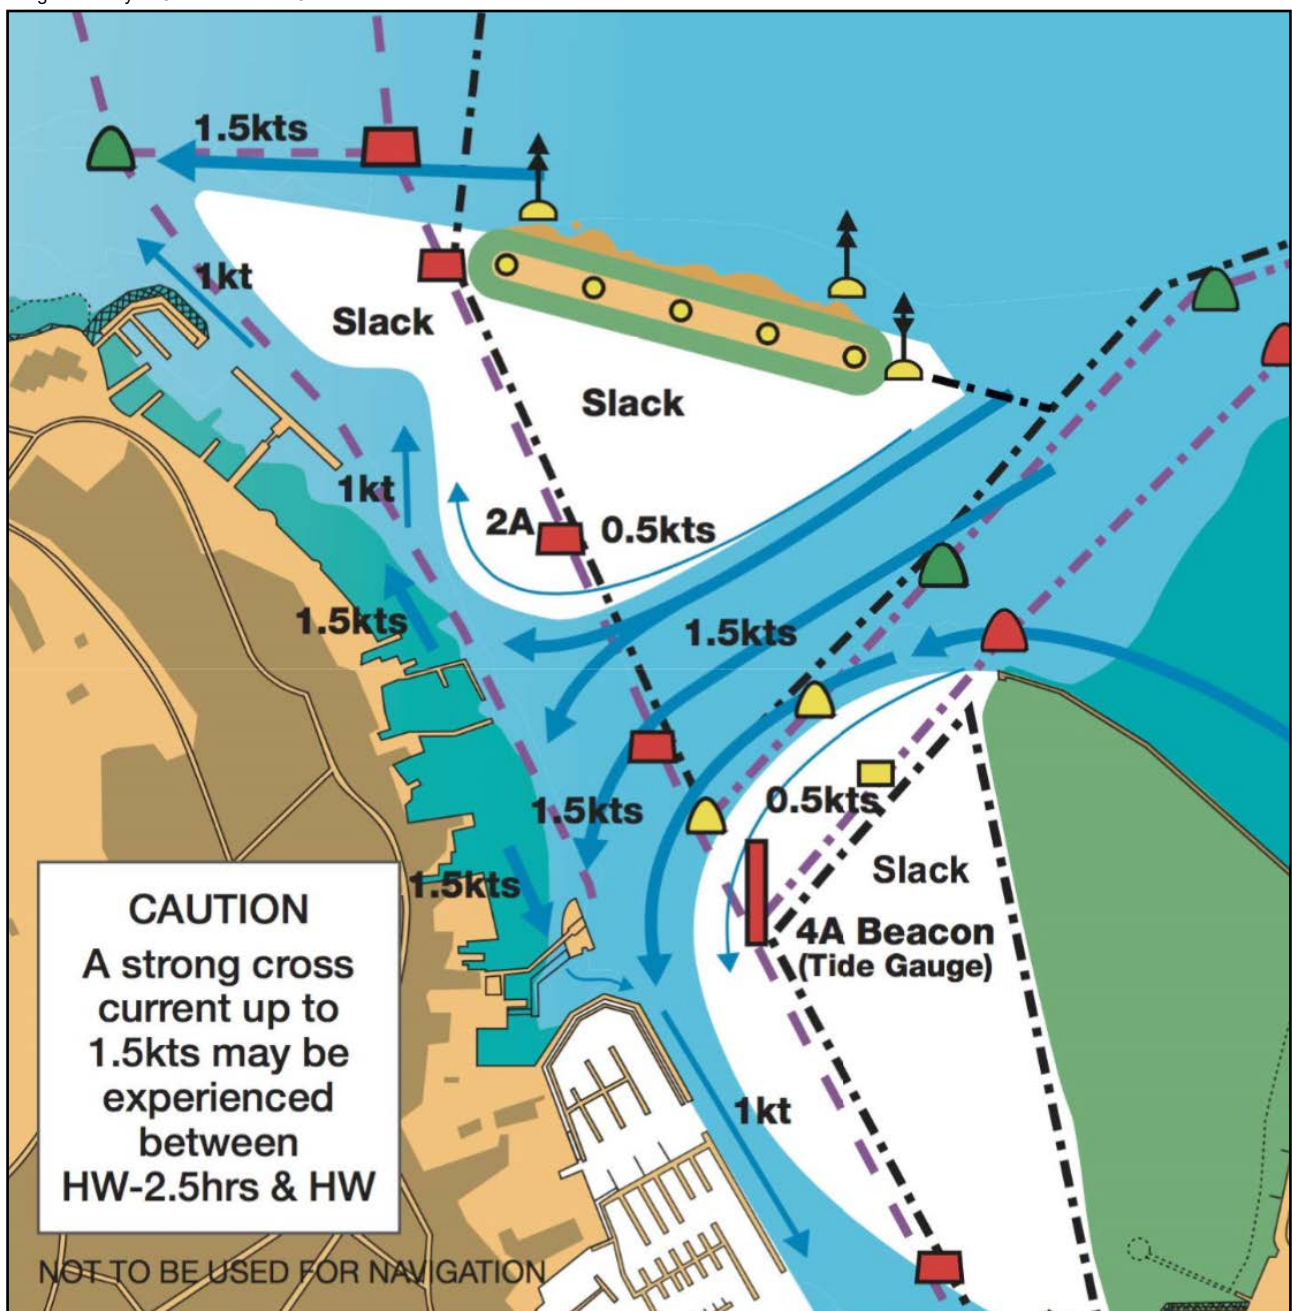
Figure 11: Current flow in Cowes Harbour

At the start of the buoyed channel, into Cowes Harbour, the tidal stream flows toward the east until about 2½ hours before high water, when it changes rapidly to flow to the west. During the 2½ hour period before high water the flood tide into Cowes Harbour and the Medina river flows from east to west in way of the small boat channel, and across into the main channel, where it splits, with the main flow into the Medina (**Figure 11**). The effects of the cross-currents are more apparent during spring tides.

The accident occurred 4 days after the neap tide; high water was at 0925 with a height of 3.9m. Cross-currents were anticipated by the master but not expected to be very strong.

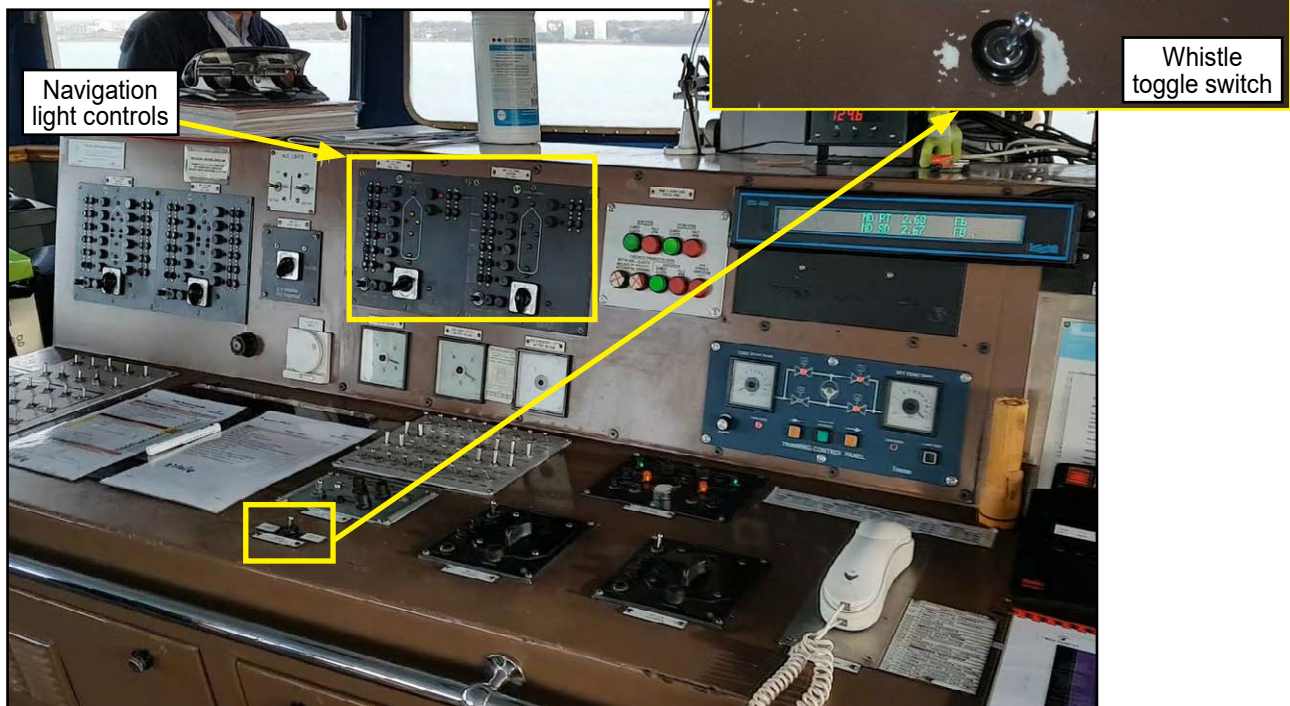
**Figure 16:** Whistle toggle switch and navigation lights controls

Because *Red Falcon* was fitted with one ECS unit and slave displays, the heading line, and therefore orientation of the ship shape, was manually changed each time the ferry changed direction in Southampton or Cowes. The heading signal was linked electronically to the whistle toggle switch (labelled *Whistle*) located on the central administration console (**Figure 16**). When the whistle was switched from one end of the vessel to the other, this also changed the heading line orientation on the ECS.

The bridge departure checklist included prompts to switch over the whistle and navigation lights to coincide with the vessel's orientation. It did not refer to the orientation of the heading line on the ECS.

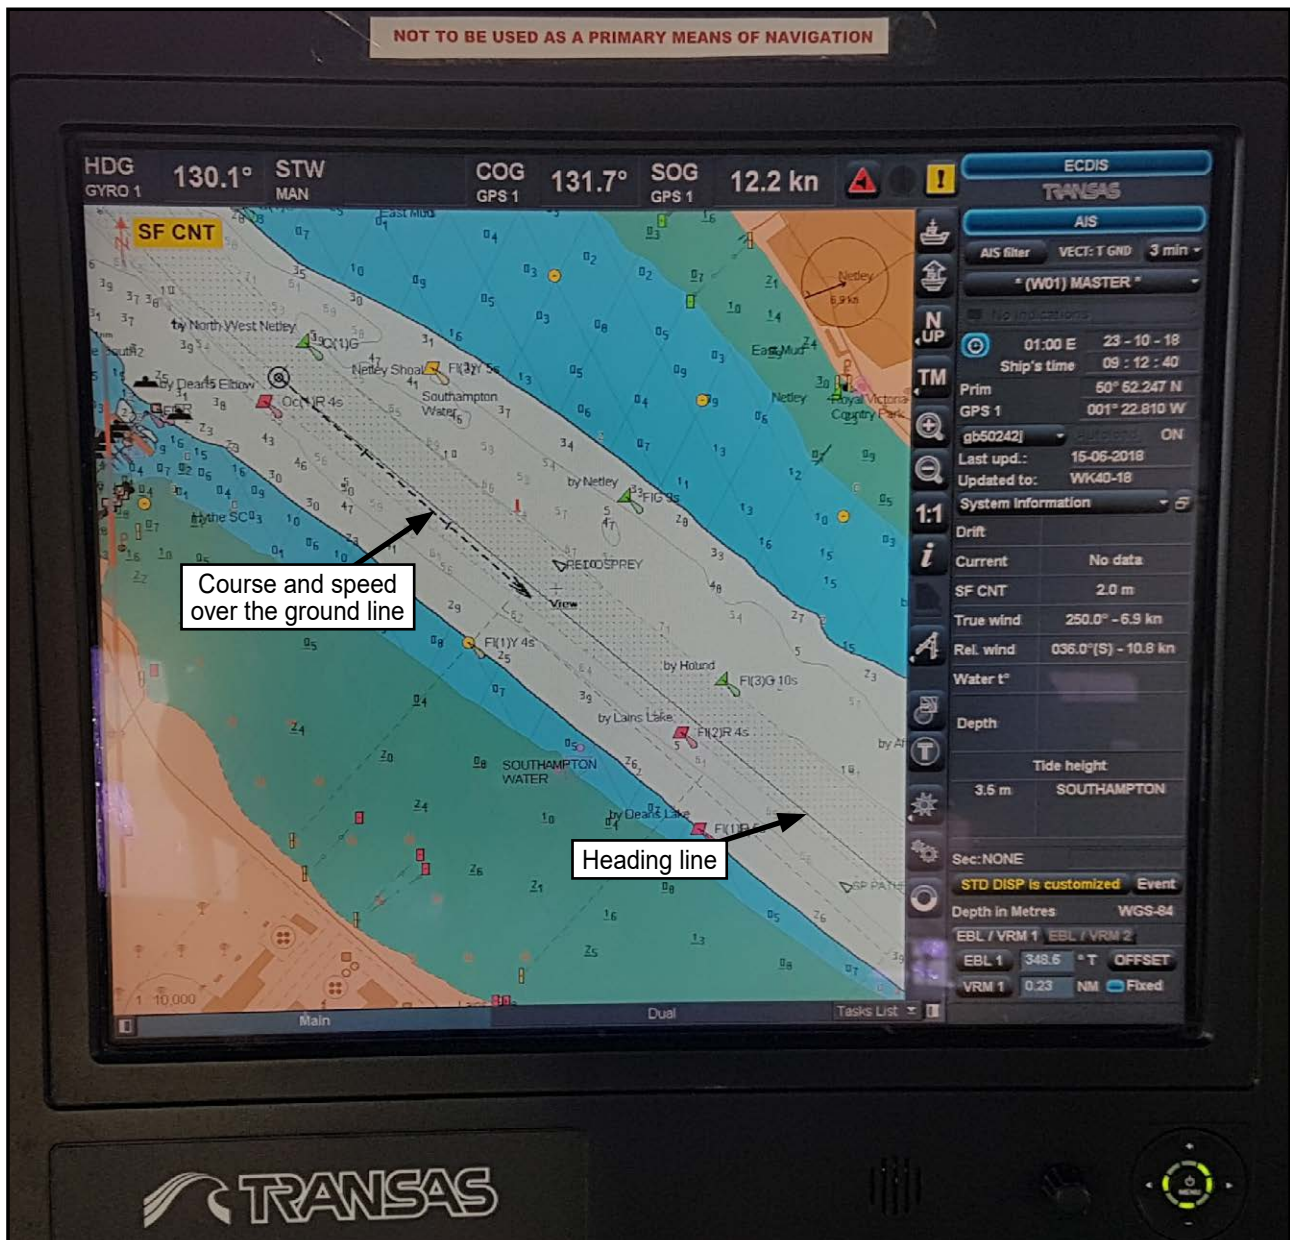
Figure 17: Electronic Chart System display

Due to the nature of the information received from the satellite systems and the time taken to display the processed information, there was a short time lag of about 1 second between the information being received and it being displayed on the ECS screens. This resulted in the ship's shape moving across the screen with a motion that was not smooth.

Once the master had moved to the side of the bridge control console, his focus was on the ECS, and the information shown on its display drove his decision-making as it became his principal navigation aid (**Figure 17**). This situation would not have been helped by the slight time delay on positional information being updated on the ECS.
